Smoke and Dye Testing Summary

High Level Sewershed

| Test ID | Test Type | Date Inspected | Company / Super. | Blower MH | Ground Condition | Notification Made? | Total Length |
|---|---|---|---|---|---|---|---|
| S1028-213 | Smoke | 8/10/2009 | ADS/TM | S19KK_025MH | Dry | Yes | 401.17 |

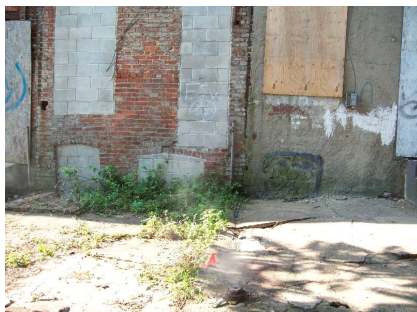
Picture \S1028-213-OB01-P01.jpg

Obs_ID S1028-213-OB01
Address 1923 Walbrook Ave
Status Private
Source Cleanout

Comments Smoke from above-grade cleanout in paved concrete in back yard. 1923 Walbrook Ave.

Comments Back of house, 1923 Walbrook Ave.

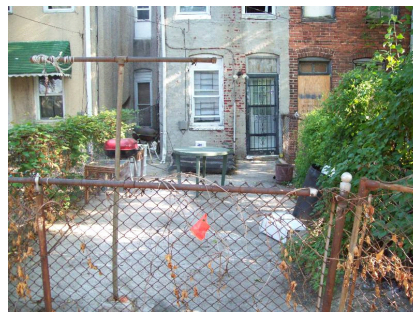
Picture \S1028-213-OB02-P01.jpg

Obs_ID S1028-213-OB02
Address 1918 Herbert St
Status Private
Source Cleanout

Comments Smoke from cleanout in paved concrete in back yard. 1918 Herbert St.

Comments Back of house, 1918 Herbert St.
